CU Anschutz Parking Lot Repairs (23-01226)

CU Anschutz Medical Campus
Aurora, Colorado

Martin/Martin, Inc. Project No.: 22.1635

February 10, 2023

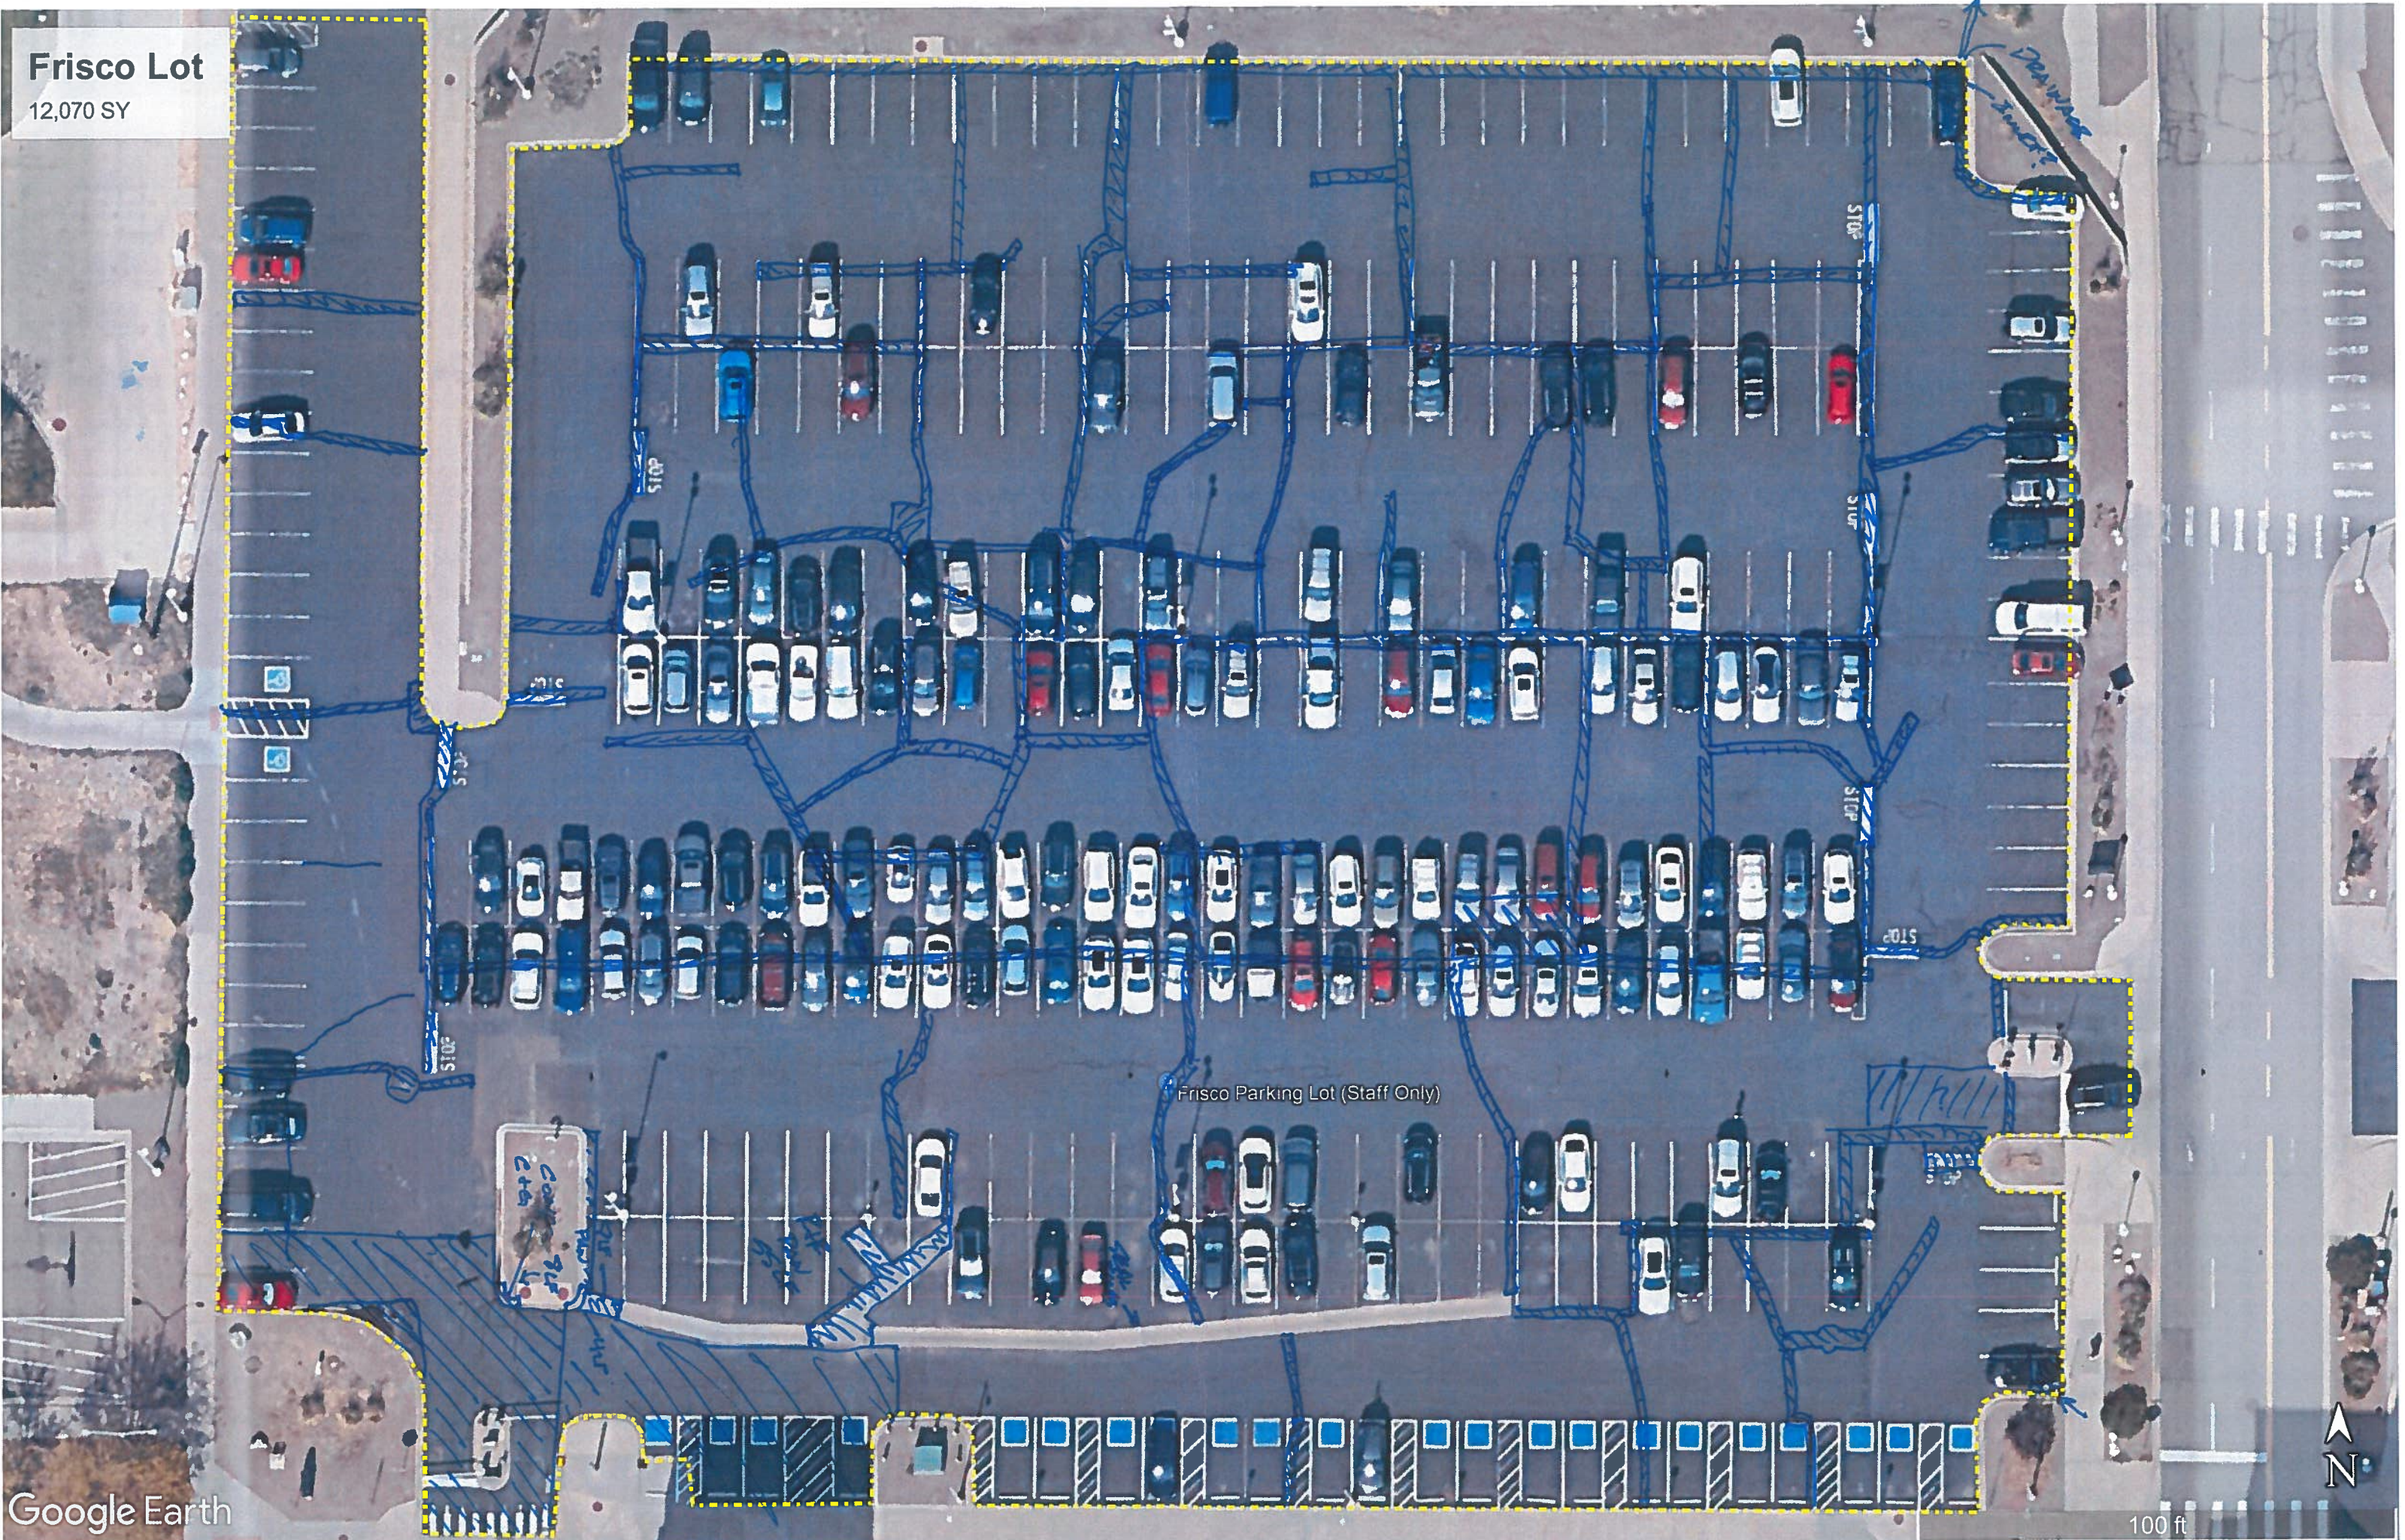
Evergreen Lot

PUMPED
PATCH
AREA

LOT LINE
PUMPED
PATCH

Left side of
road is
high water
x 1000

SEAL
Pavement
Along curb

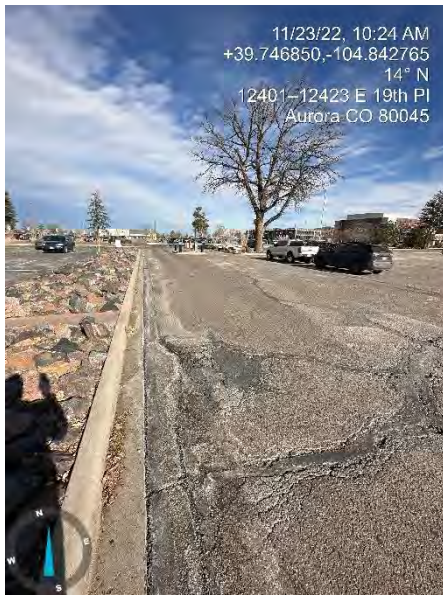
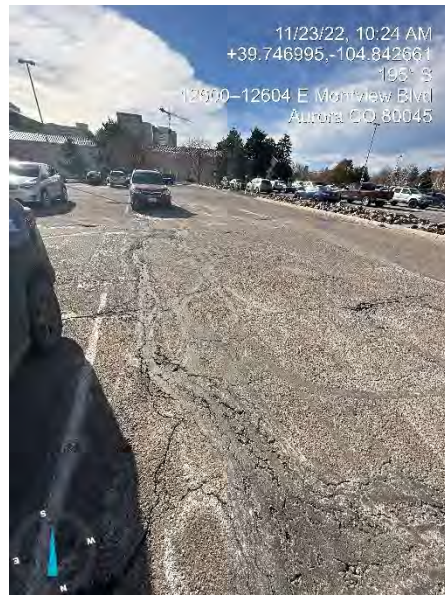
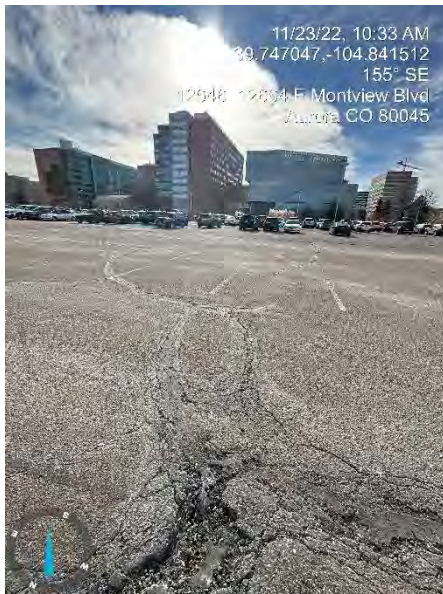
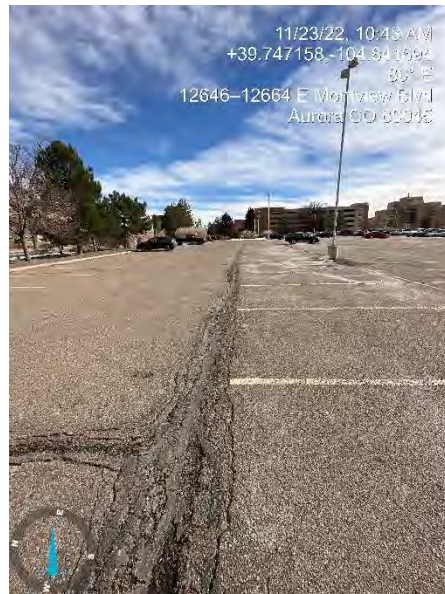
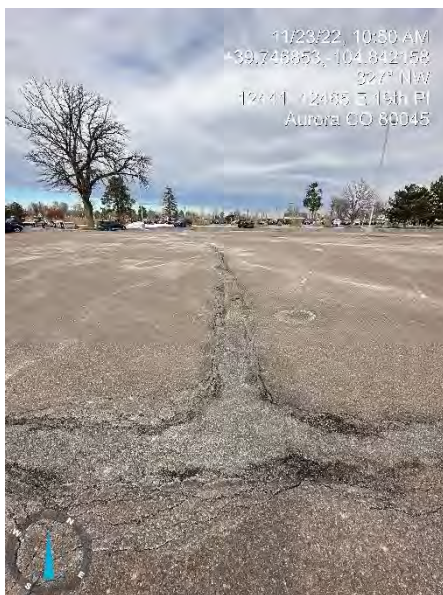
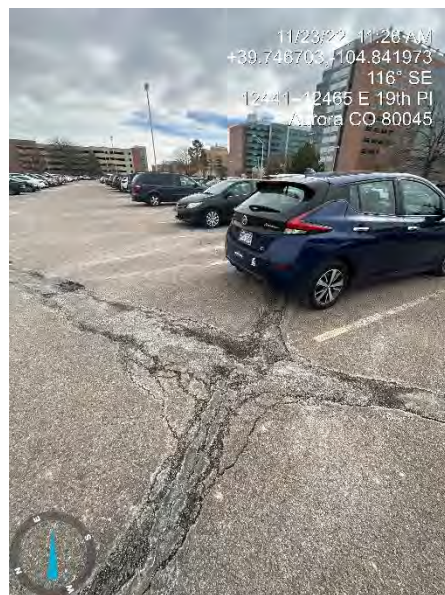
ASPEN LOT

This lot has significant large longitudinal cracking throughout that is greater than 1" in width. For these areas, it is recommended to remove/replace the asphalt to full depth and fix any subgrade issues that may have contributed to the large cracking. For smaller cracks than 1" in width, a hot applied joint sealant is recommended. Previous areas have been patched in the lot and appear to still be in good condition, with a joint sealant recommended around the patched areas. Lastly, a few concrete areas near the northwest entrance of the lot were observed to be deteriorated and are recommended to be removed/replaced (gutter pan and curb/gutter).

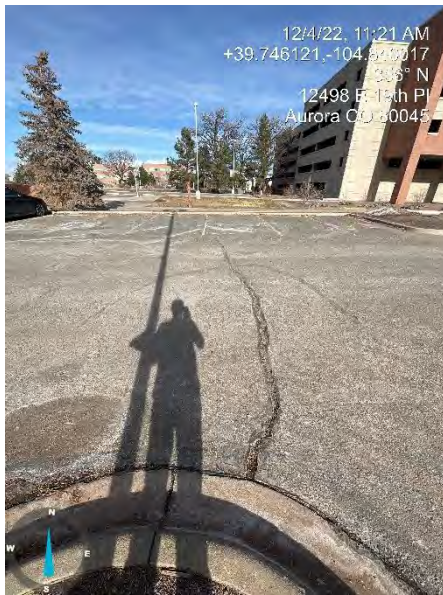
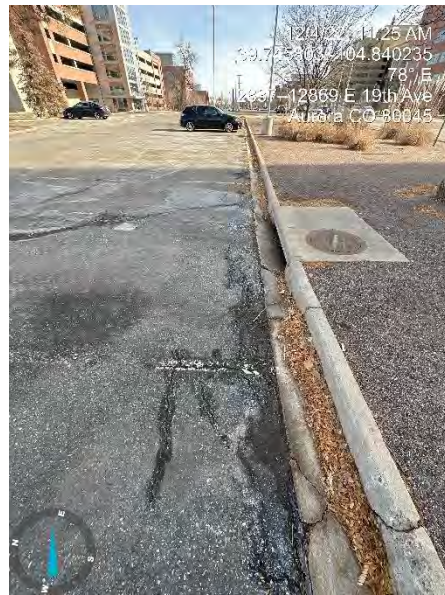
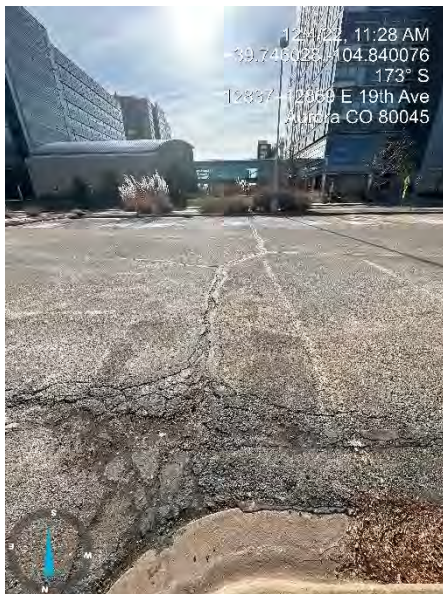
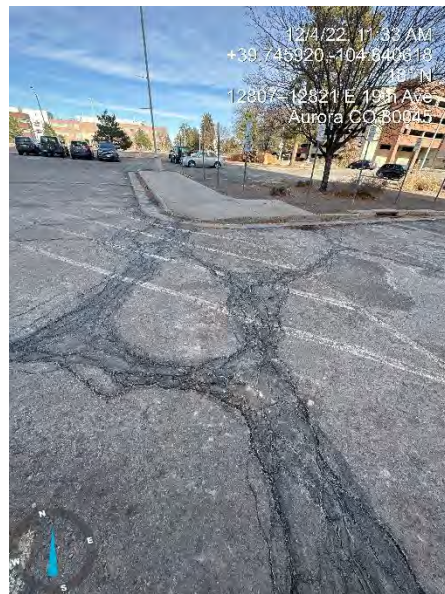
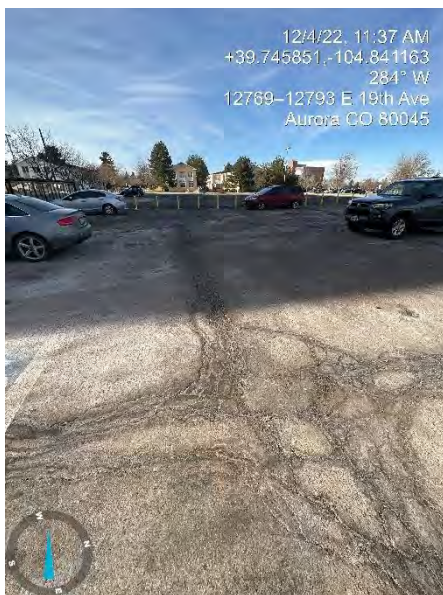
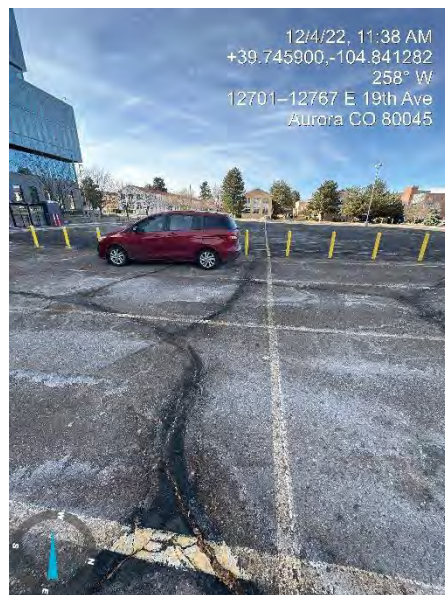
BRECKENRIDGE LOT

This lot has significant large longitudinal cracking throughout that is greater than 1" in width. For these areas, it is recommended to remove/replace the asphalt to full depth and fix any subgrade issues that may have contributed to the cracking. For smaller cracks than 1" in width, a hot applied joint sealant is recommended.

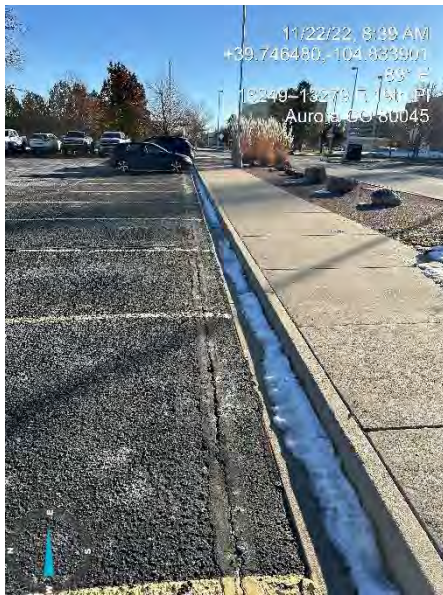
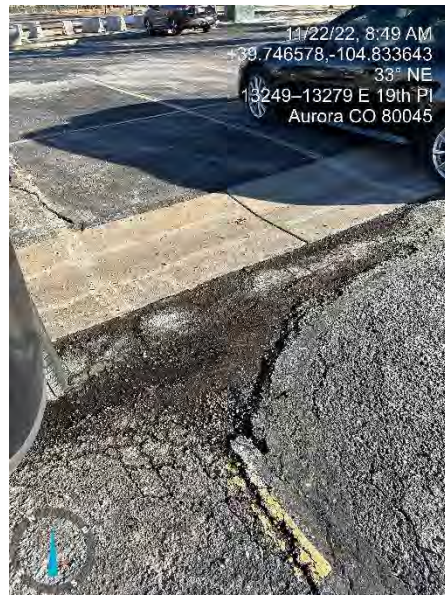
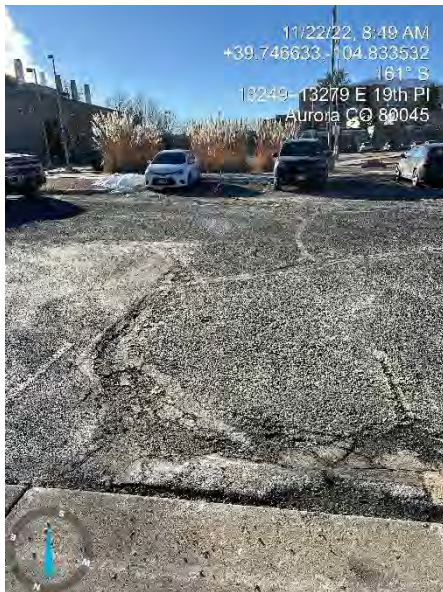
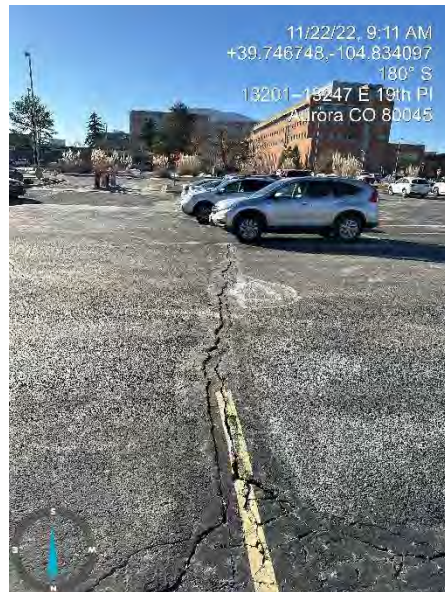
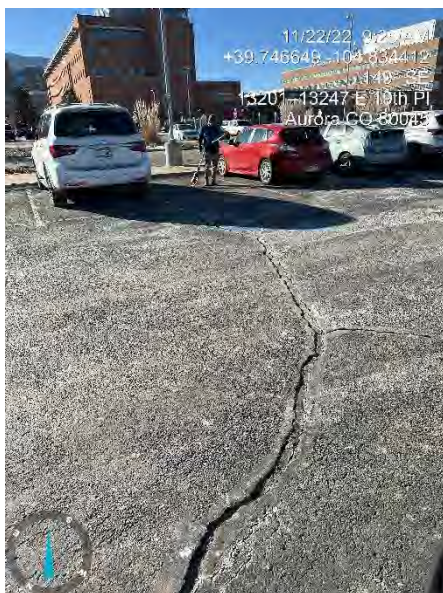
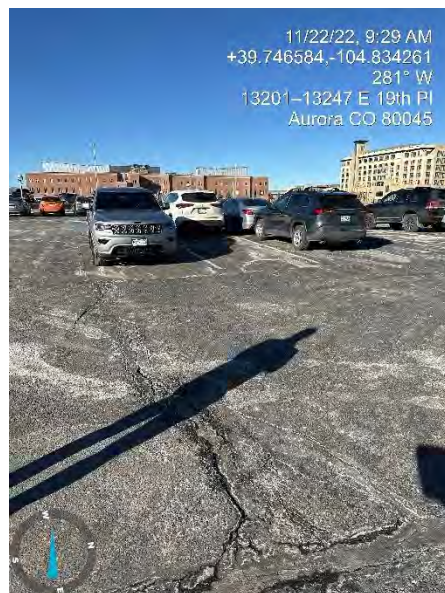
DURANGO LOT

This lot has some large longitudinal cracking throughout that is greater than 1" in width. For these areas, it is recommended to remove/replace the asphalt to full depth and fix any subgrade issues that may have contributed to the large cracking. For smaller cracks than 1" in width, a hot applied

joint sealant is recommended. Previous areas have been patched in the lot and appear to still be in good condition, with a joint sealant recommended around the patched areas.

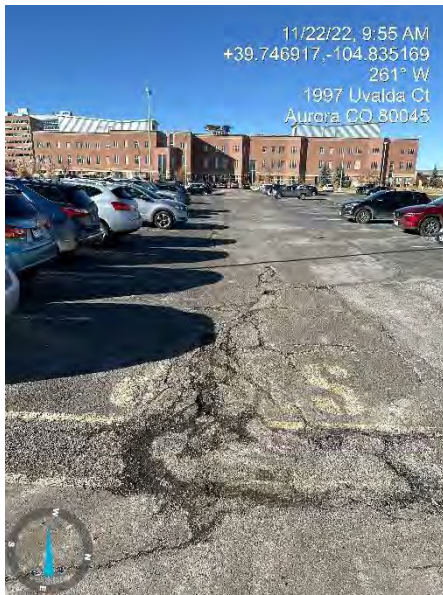
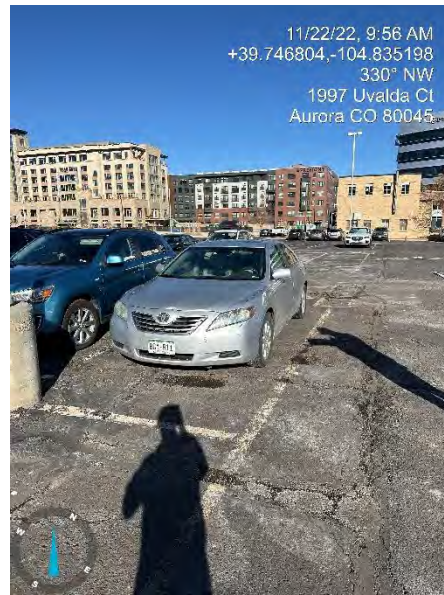
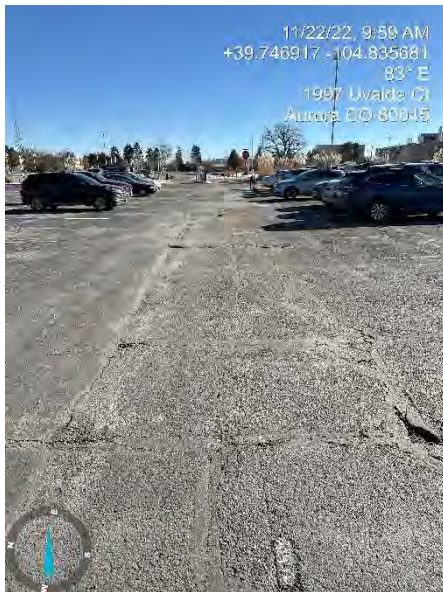
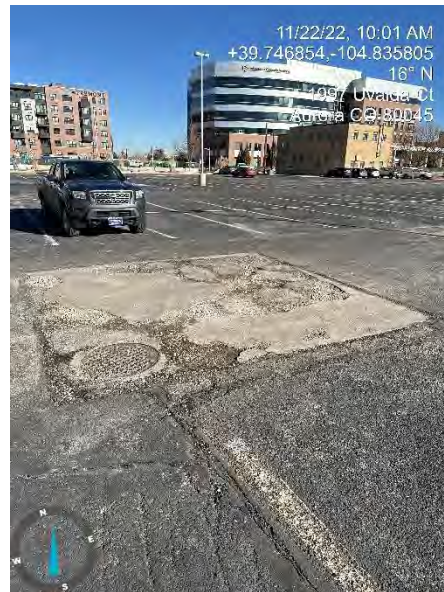
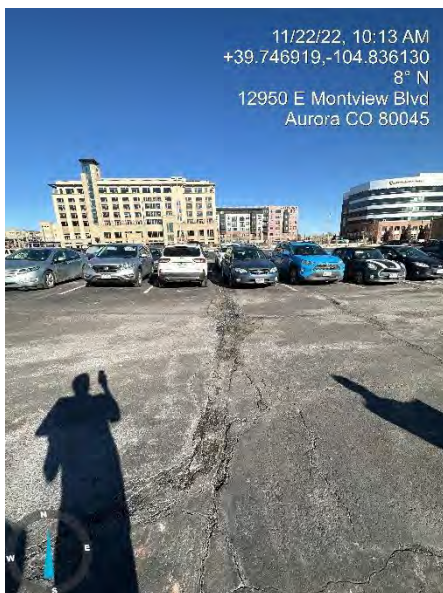
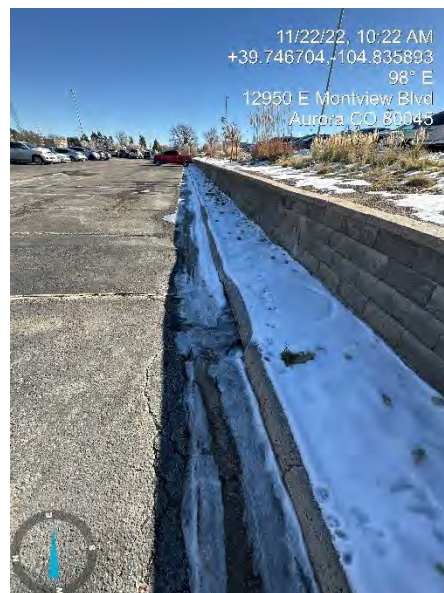
EVERGREEN LOT

This lot has some large longitudinal cracking throughout that is greater than 1" in width. For these areas, it is recommended to remove/replace the asphalt to full depth and fix any subgrade issues that may have contributed to the large cracking. For smaller cracks than 1" in width, a hot applied joint sealant is recommended. There are also some areas of large alligator cracking present that are recommended to be removed/replaced to address the apparent poor subgrade conditions. Also, a concrete vault area in the middle of the lot was observed to be deteriorated and is recommended for the top section to be removed/replaced. Lastly, there were some areas of poor drainage observed on the south side of the lot. To address these, it would first be recommended to explore further with a topographic survey to better understand the elevations and drainage patterns of the lot.

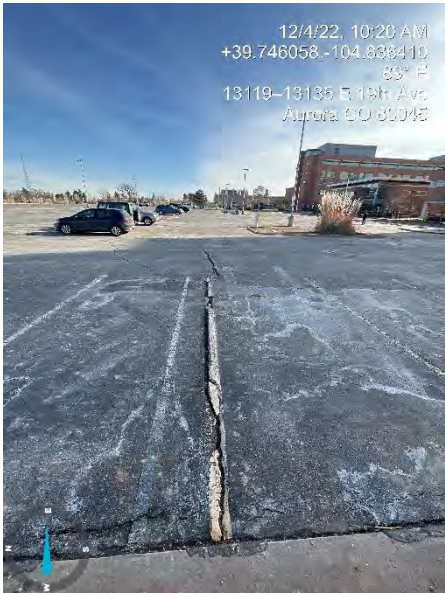
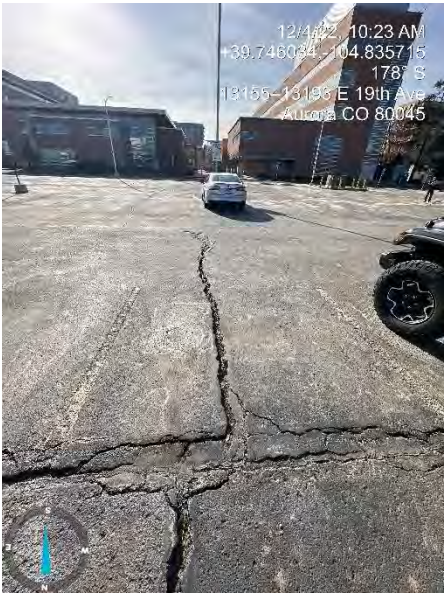
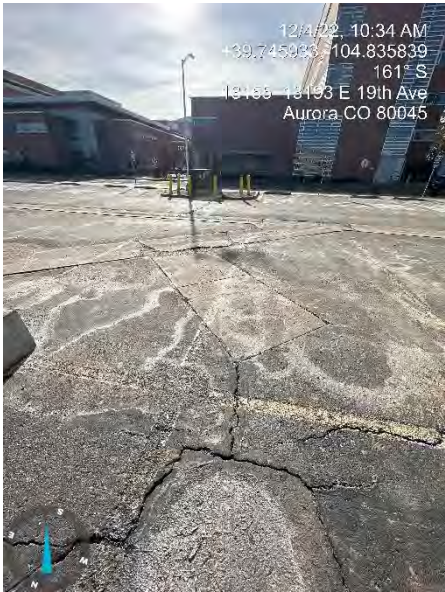
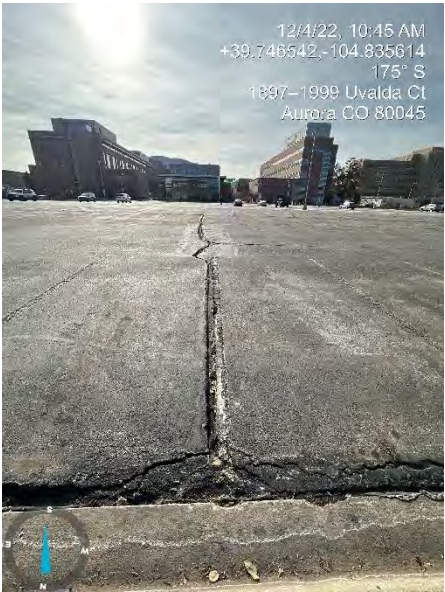
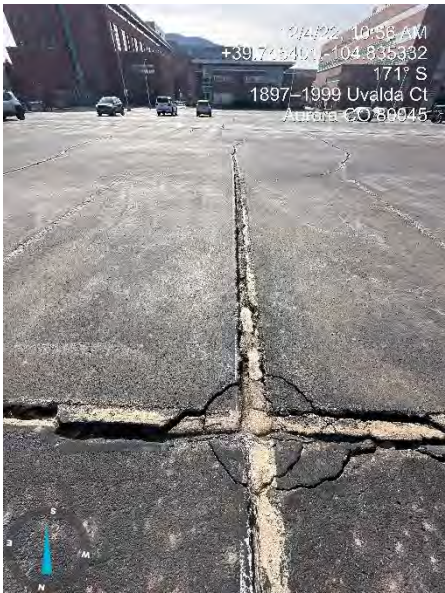
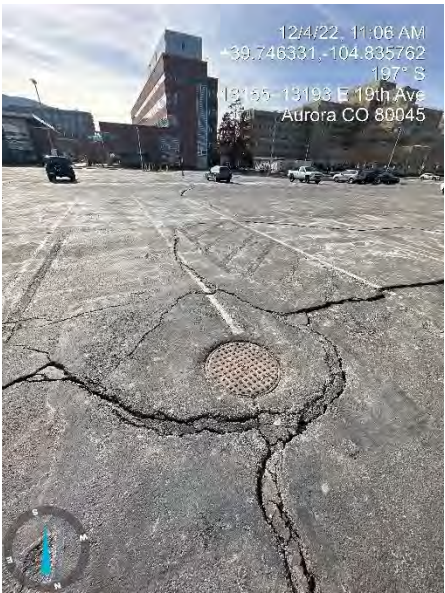
FRISCO LOT

This lot has significant large longitudinal cracking throughout that is greater than 1" in width. For these areas, it is recommended to remove/replace the asphalt to full depth and fix any subgrade issues that may have contributed to the large cracking. For smaller cracks than 1" in width, a hot applied joint sealant is recommended. Lastly, a few concrete areas near the southwest and northeast sections of the lot were observed to be deteriorated and are recommended to be removed/replaced (gutter pan and curb/gutter).

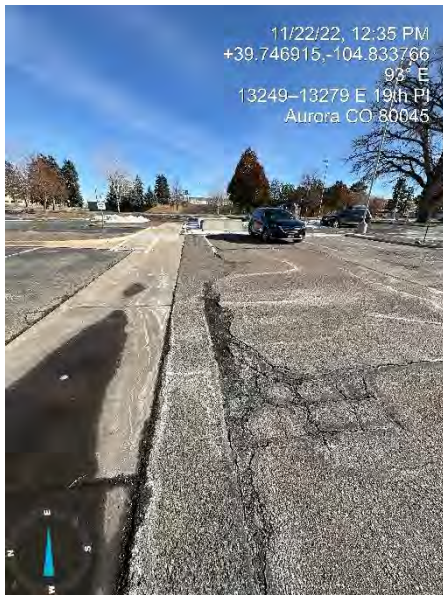
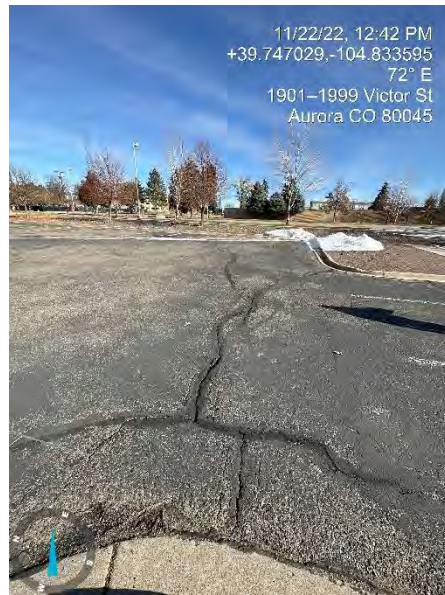
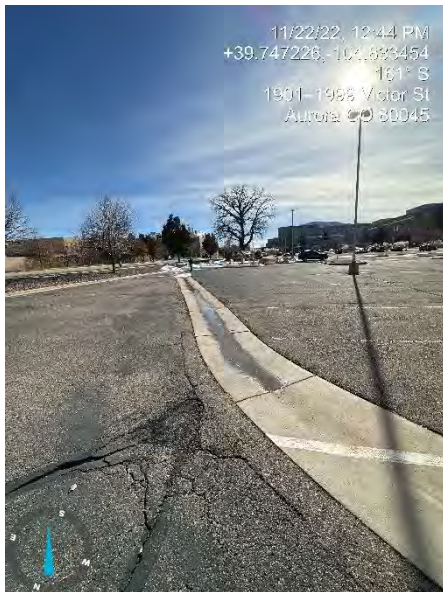
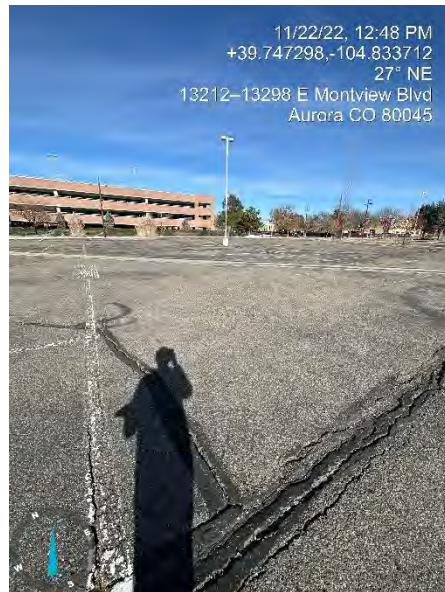
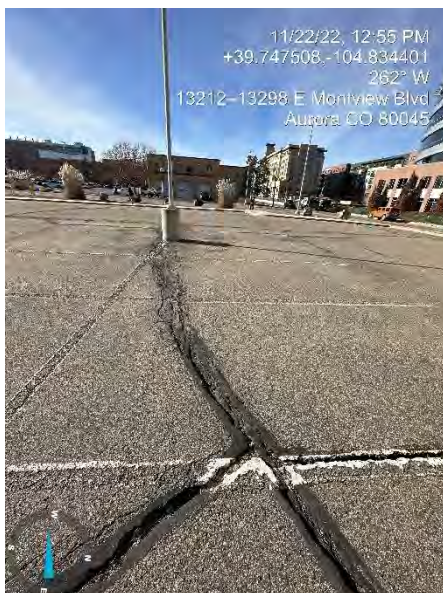
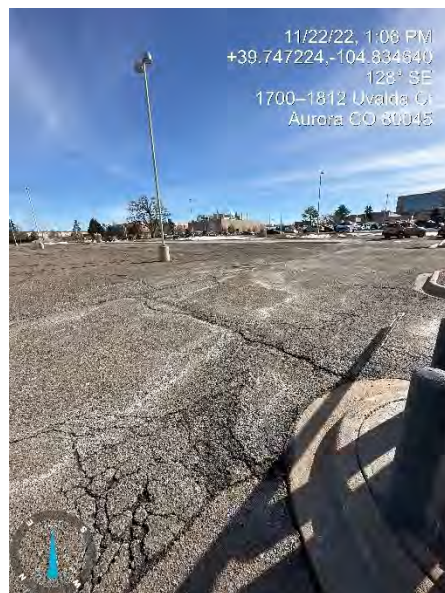
LEADVILLE LOT

This lot has some large longitudinal cracking throughout that is greater than 1" in width. For these areas, it is recommended to remove/replace the asphalt to full depth and fix any subgrade issues that may have contributed to the large cracking. For smaller cracks than 1" in width, a hot applied joint sealant is recommended. There are also some areas of large alligator cracking and raveling present that are recommended to be removed/replaced to address the apparent poor subgrade conditions. Lastly, a few concrete areas throughout the lot were observed to be deteriorated and are recommended to be removed/replaced (gutter pan and curb/gutter).

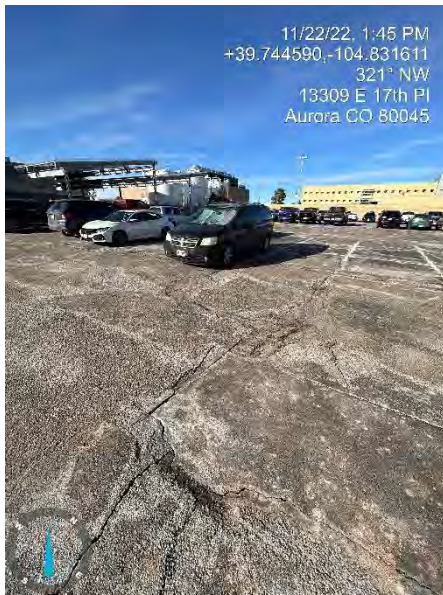
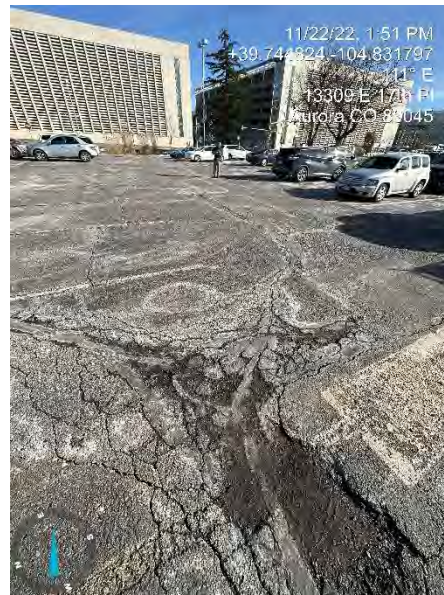
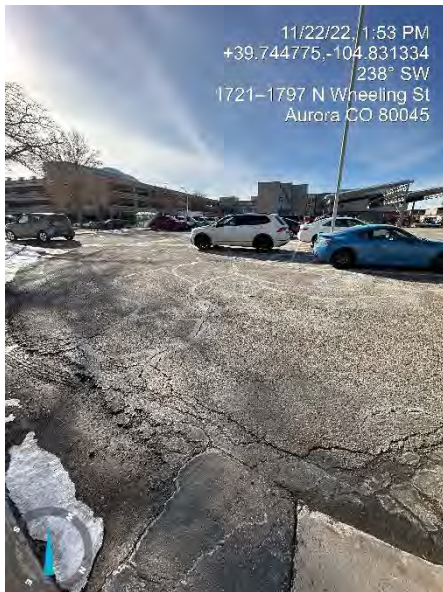
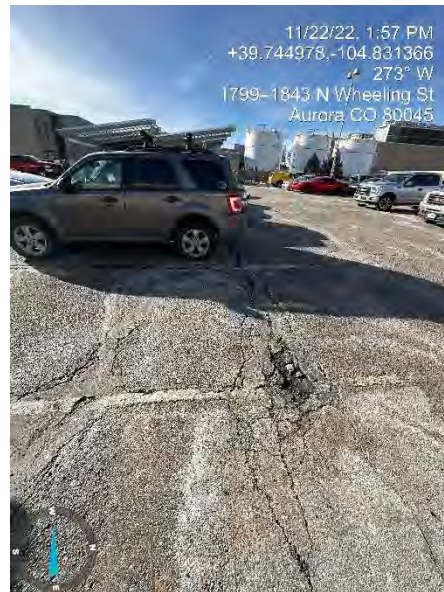
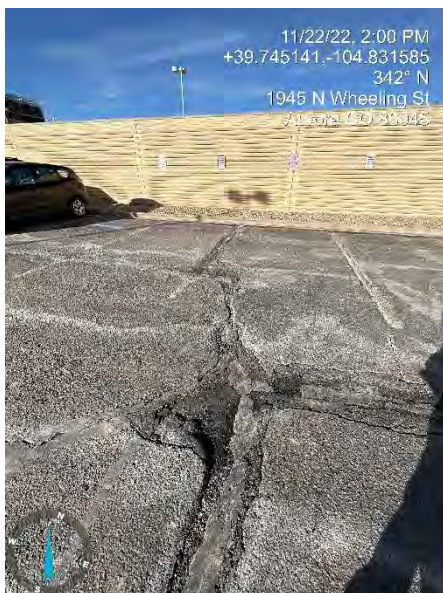
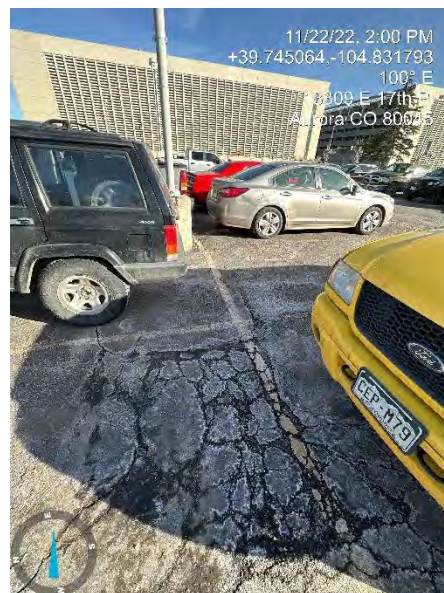
PURGATORY LOT

This lot has significant large longitudinal cracking throughout that is greater than 1" in width. For these areas, it is recommended to remove/replace the asphalt to full depth and fix any subgrade issues that may have contributed to the large cracking. For smaller cracks than 1" in width, a hot applied joint sealant is recommended. Previous areas have been patched in the lot and appear to still be in good condition, with a joint sealant recommended around the patched areas. There are also some areas of large alligator cracking present that are recommended to be removed/replaced to address the apparent poor subgrade conditions.
