CU Anschutz Parking Lot Repairs

CU Anschutz Medical Campus
Aurora, Colorado

Martin/Martin, Inc. Project No.: 22.1635

Revised August 24, 2023

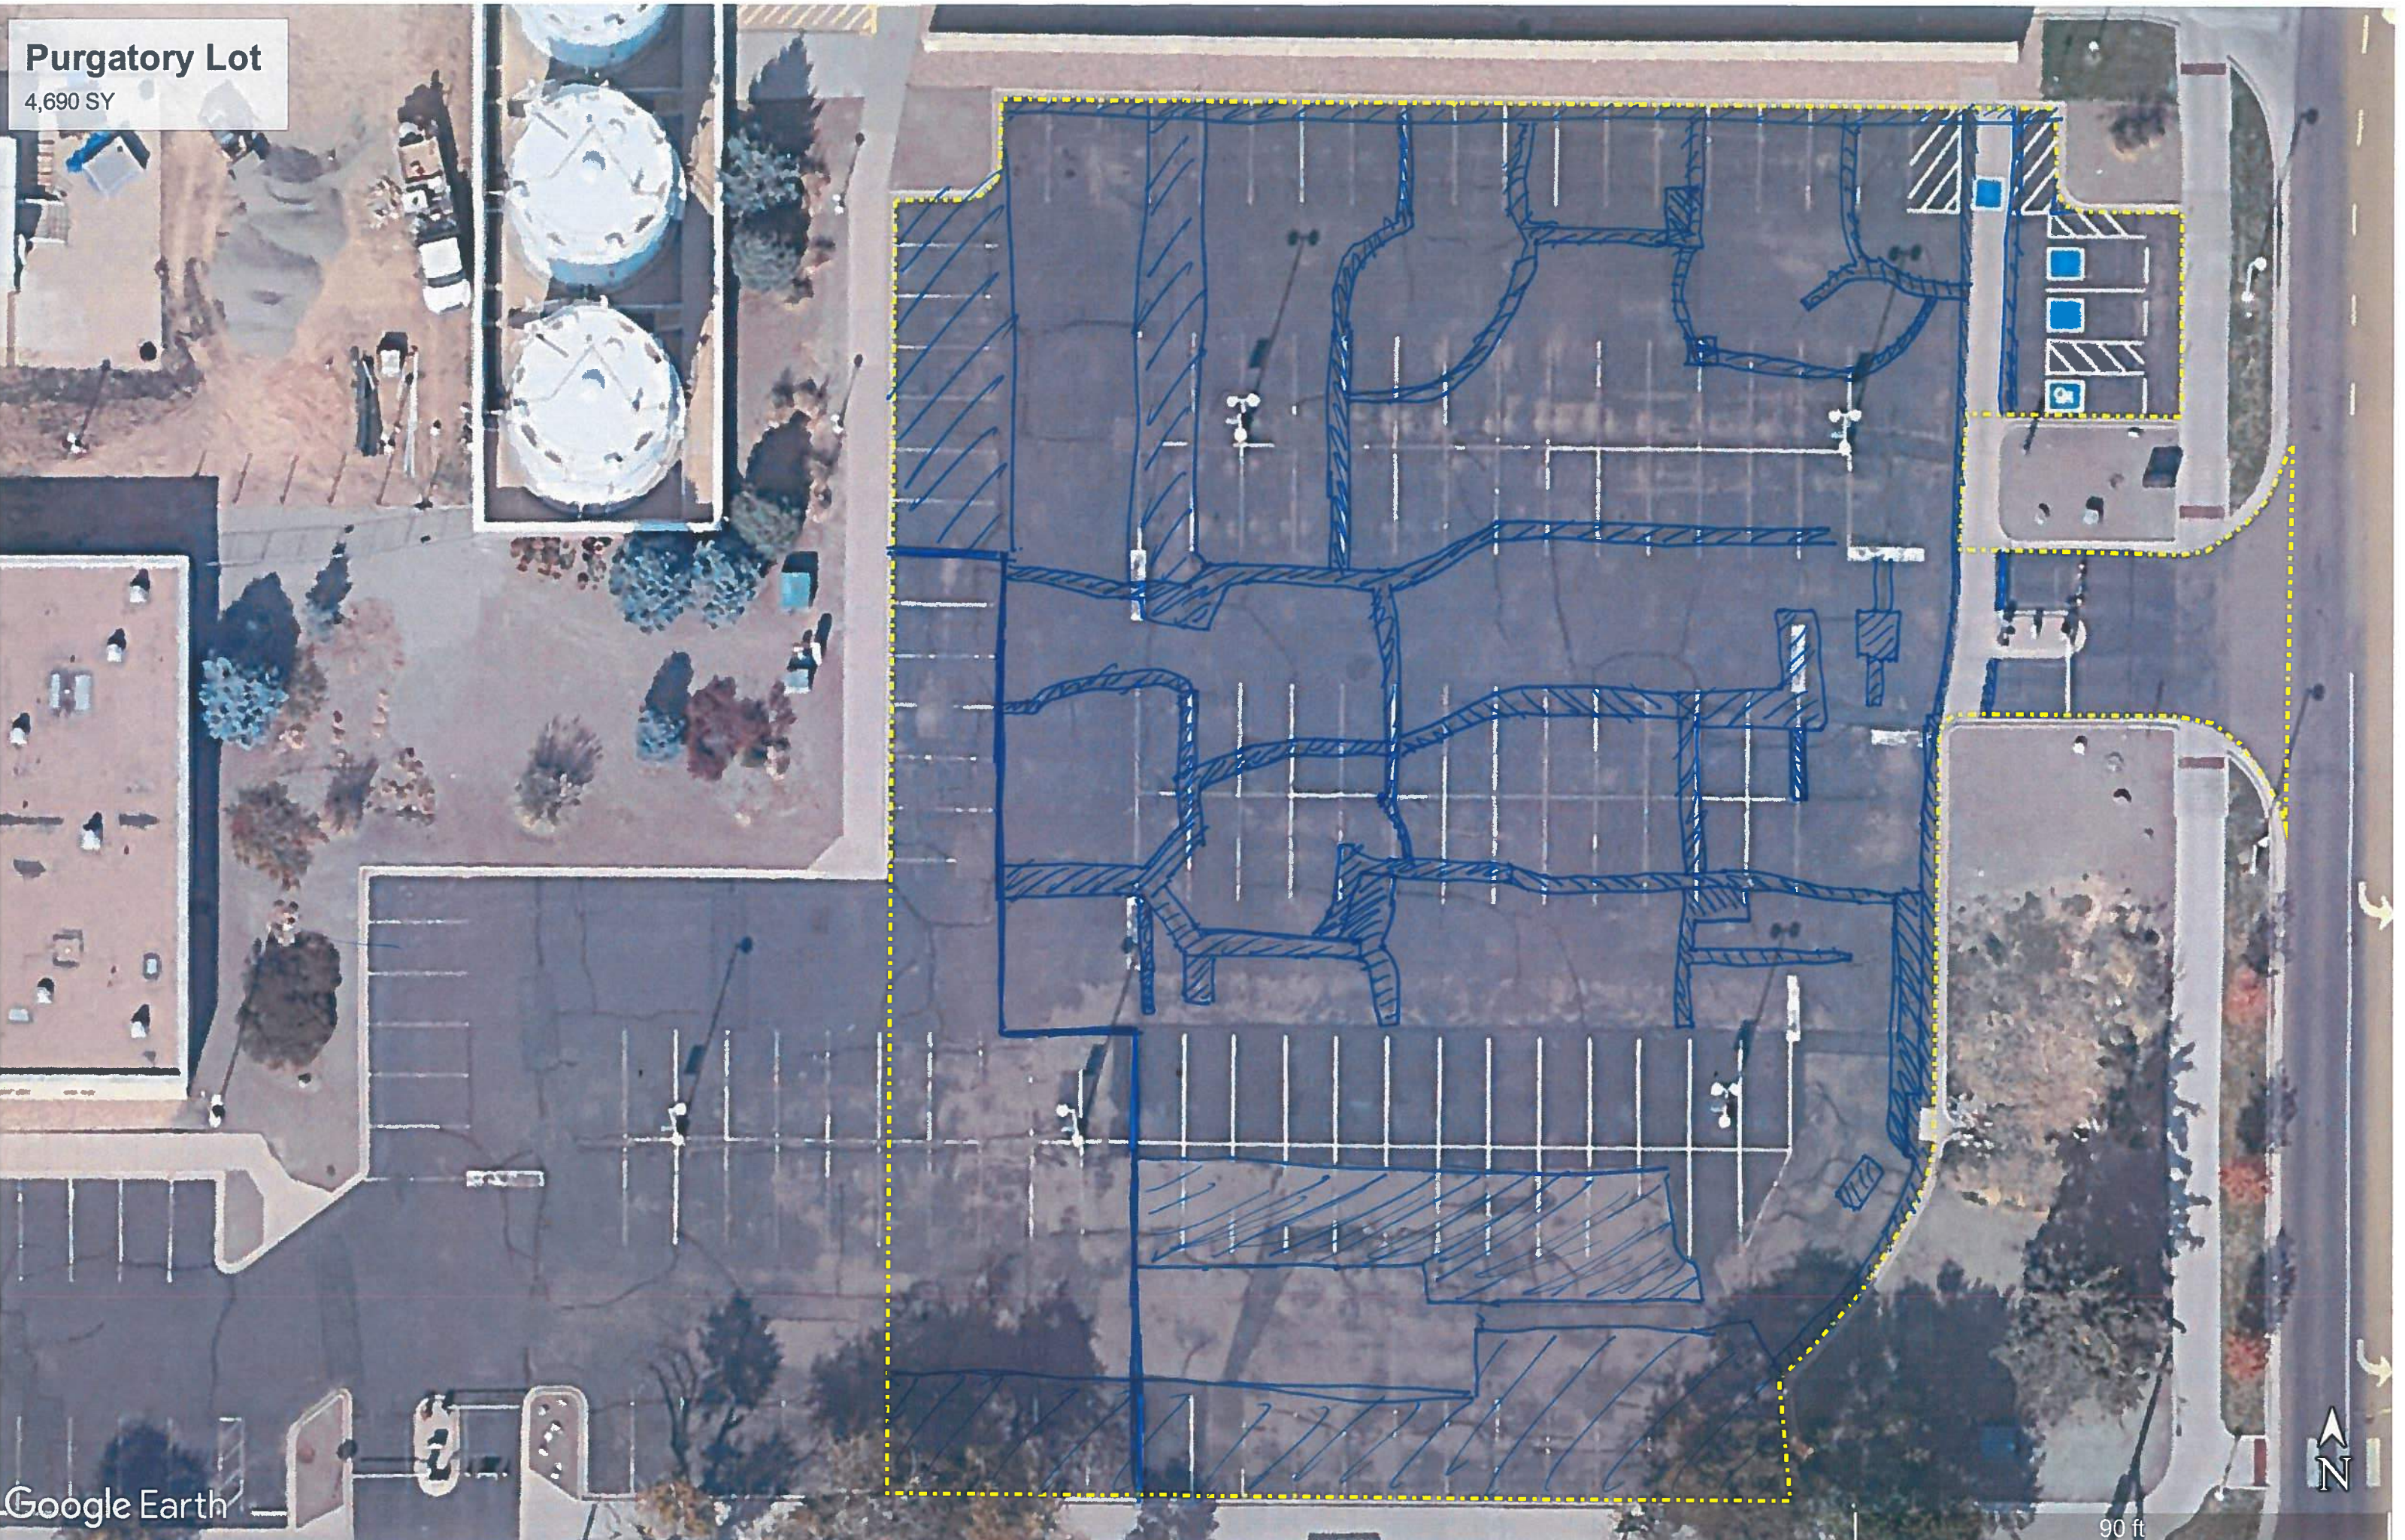
EXHIBIT A – EXISTING CONDITONS (FIELD NOTES)

CRACK SEAL FOLLOWS
CRACKS IN DRAWING

FOR TRAVELLED
AREAS MAY
NEED TO CORE
OR VERIFY DEPTH
FOR M+D
VS FULL DEPTH

SEAL
SURFACE
OF
POT
PATCH

TRIMMED DRAIN
FOR GRAVITY FLOW

REPAIR
POT
PATCH

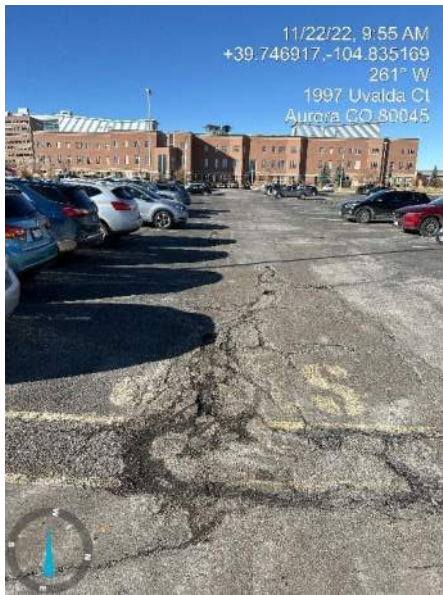
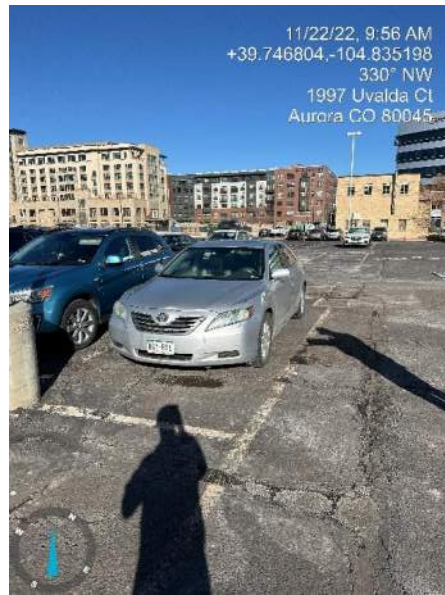
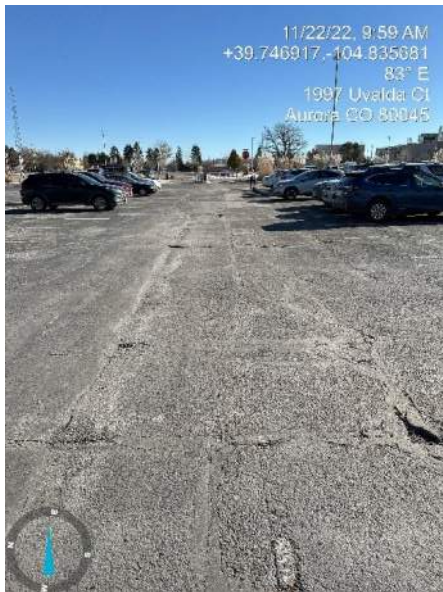
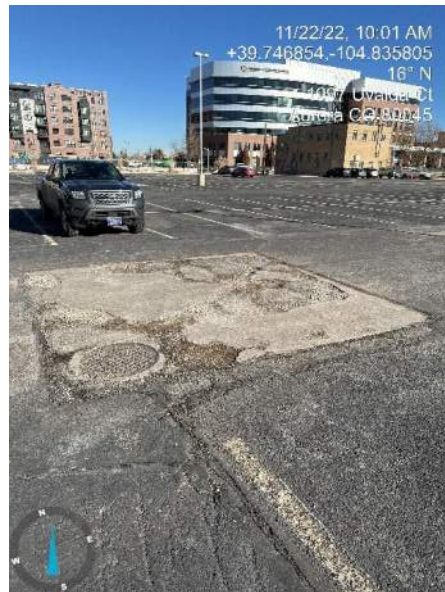
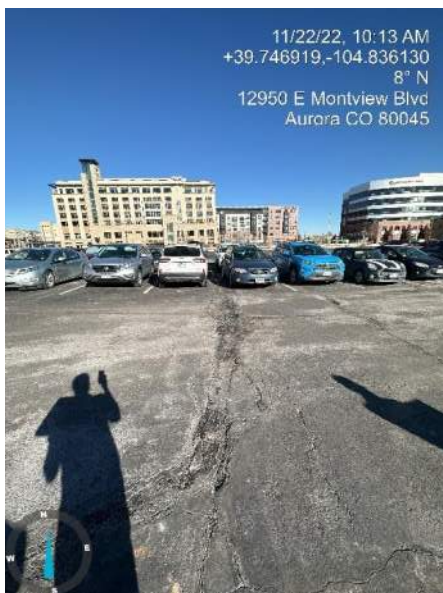
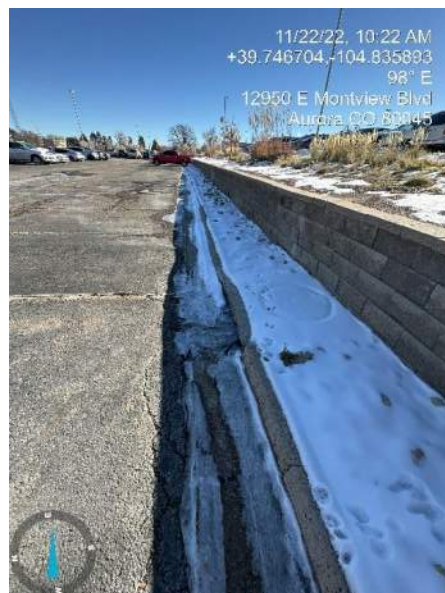
EVERGREEN LOT

This lot has some large longitudinal cracking throughout that is greater than 1" in width. For these areas, it is recommended to remove/replace the asphalt to full depth and fix any subgrade issues that may have contributed to the large cracking. For smaller cracks than 1" in width, a hot applied joint sealant is recommended. There are also some areas of large alligator cracking present that are recommended to be removed/replaced to address the apparent poor subgrade conditions. Also, a concrete vault area in the middle of the lot was observed to be deteriorated and is recommended for the top section to be removed/replaced. Lastly, there were some areas of poor drainage observed on the south side of the lot. To address these, it would first be recommended to explore further with a topographic survey to better understand the elevations and drainage patterns of the lot.

- Evergreen Lot: Asphalt Full-Depth Repair (Remove/Replace) of the recommended areas and intermediate crack sealing, followed by Asphalt Slurry Seal of the entire lot with new pavement markings.
- Leadville Lot (Bid Alternate): Asphalt Full-Depth Repair (Remove/Replace) of the recommended areas and intermediate crack sealing, followed by Asphalt Slurry Seal of the entire lot with new pavement markings. Improvements for this lot are desired to be included as a bid alternate.
- Purgatory Lot: Asphalt Full-Depth Repair (Remove/Replace) of the recommended areas, followed by Asphalt Milling/2" Overlay of the entire lot with new pavement markings.
- As a bid alternate, it is also desired to include Asphalt Milling/2" Overlay of the Evergreen and Leadville Lots

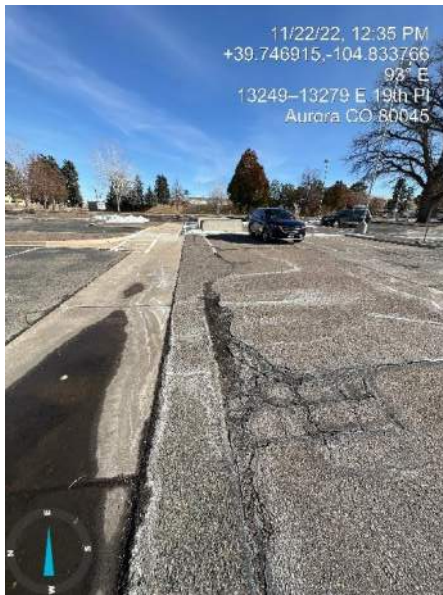
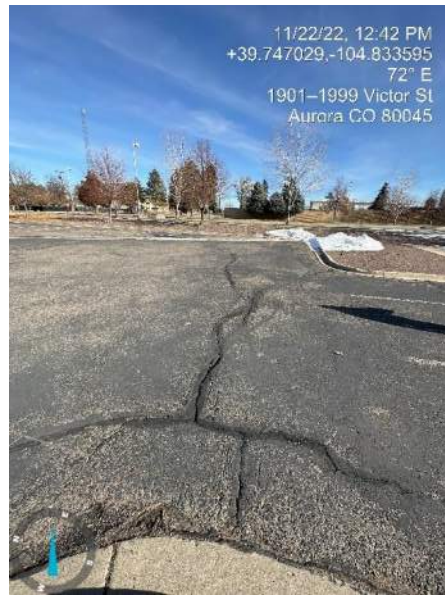
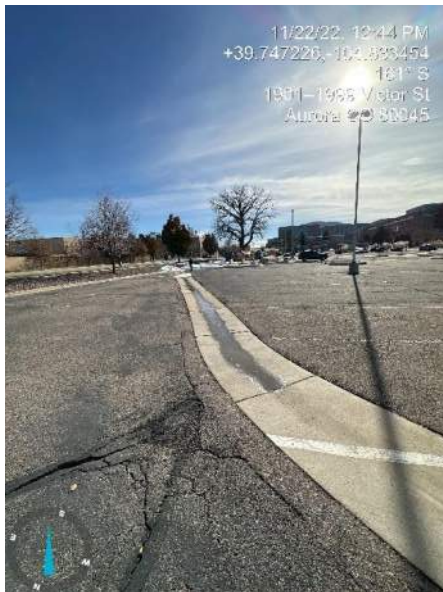
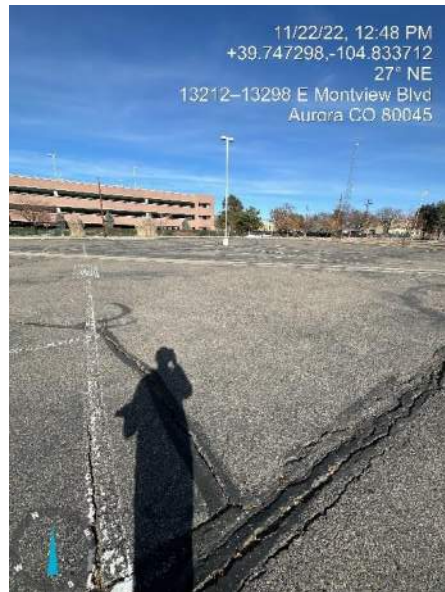
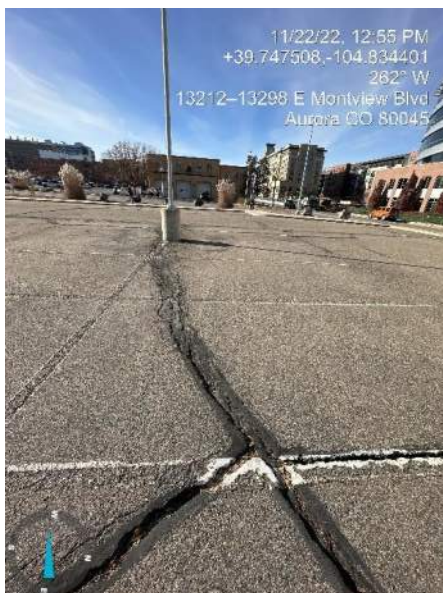
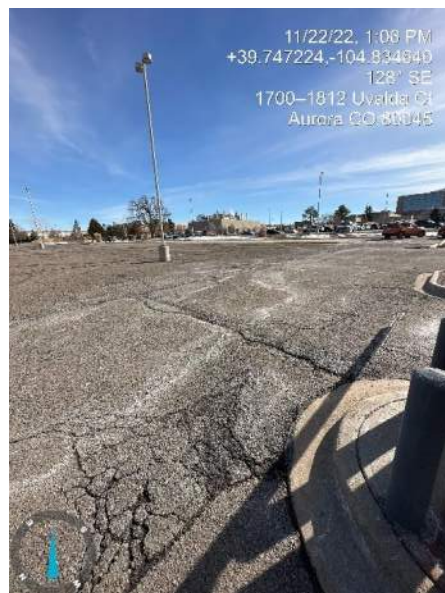
LEADVILLE LOT

This lot has some large longitudinal cracking throughout that is greater than 1" in width. For these areas, it is recommended to remove/replace the asphalt to full depth and fix any subgrade issues that may have contributed to the large cracking. For smaller cracks than 1" in width, a hot applied joint sealant is recommended. There are also some areas of large alligator cracking and raveling present that are recommended to be removed/replaced to address the apparent poor subgrade

conditions. Lastly, a few concrete areas throughout the lot were observed to be deteriorated and are recommended to be removed/replaced (gutter pan and curb/gutter).

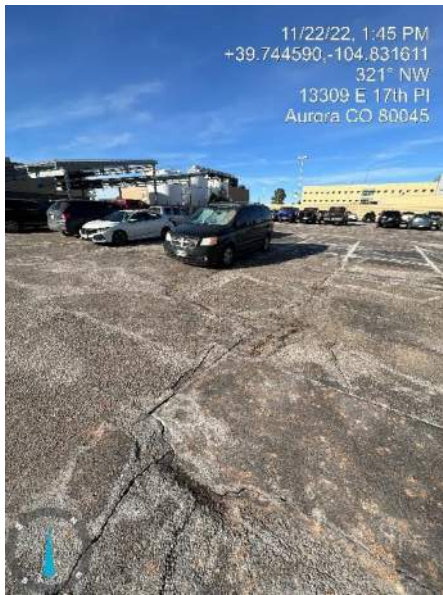
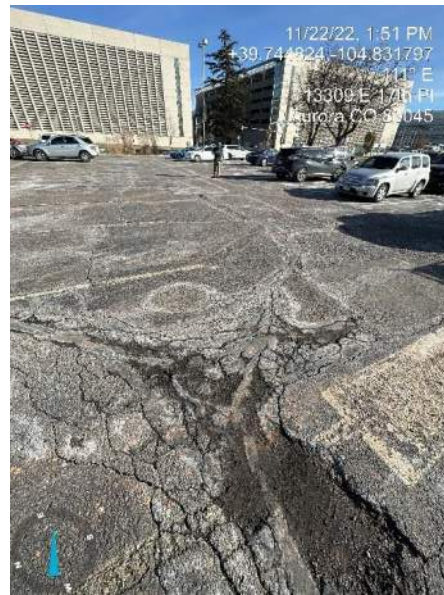
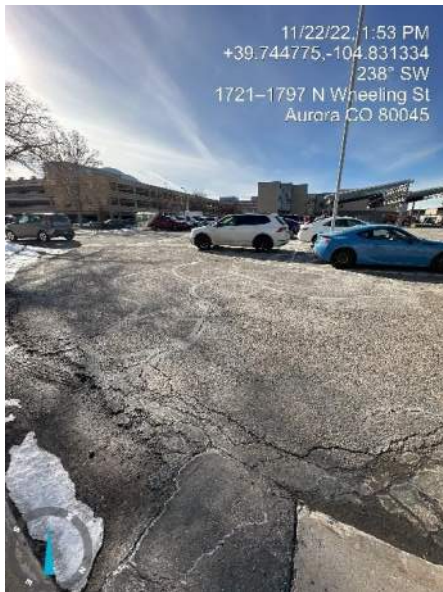
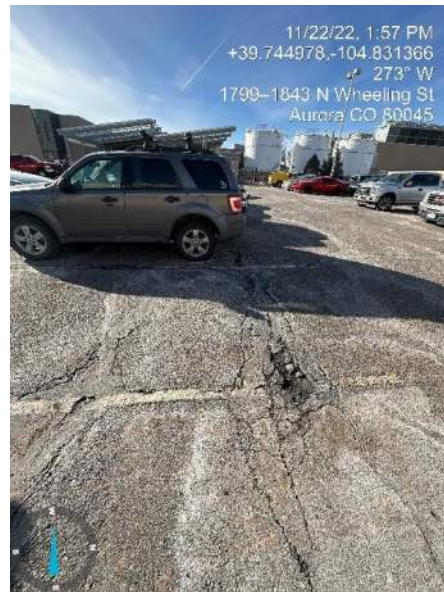
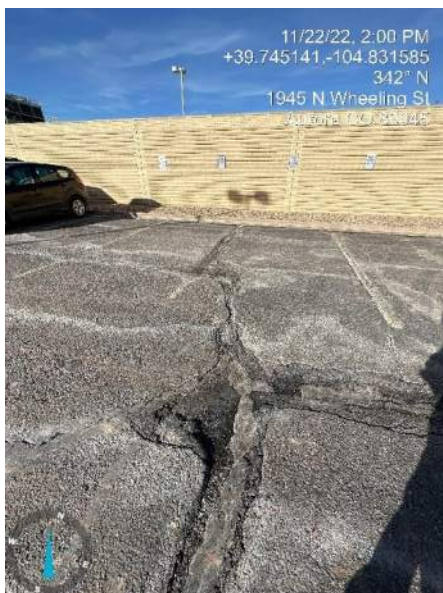
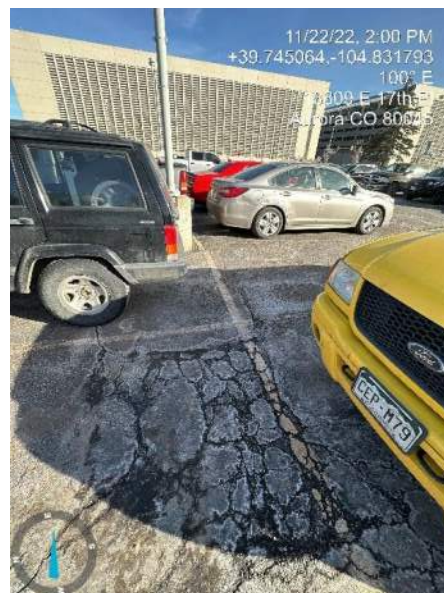
PURGATORY LOT

This lot has significant large longitudinal cracking throughout that is greater than 1" in width. For these areas, it is recommended to remove/replace the asphalt to full depth and fix any subgrade issues that may have contributed to the large cracking. For smaller cracks than 1" in width, a hot applied joint sealant is recommended. Previous areas have been patched in the lot and appear to still be in good condition, with a joint sealant recommended around the patched areas. There are also some areas of large alligator cracking present that are recommended to be removed/replaced to address the apparent poor subgrade conditions.
