CU Anschutz Parking Lot Repairs (23-01226)

CU Anschutz Medical Campus
Aurora, Colorado

Martin/Martin, Inc. Project No.: 22.1635

February 10, 2023

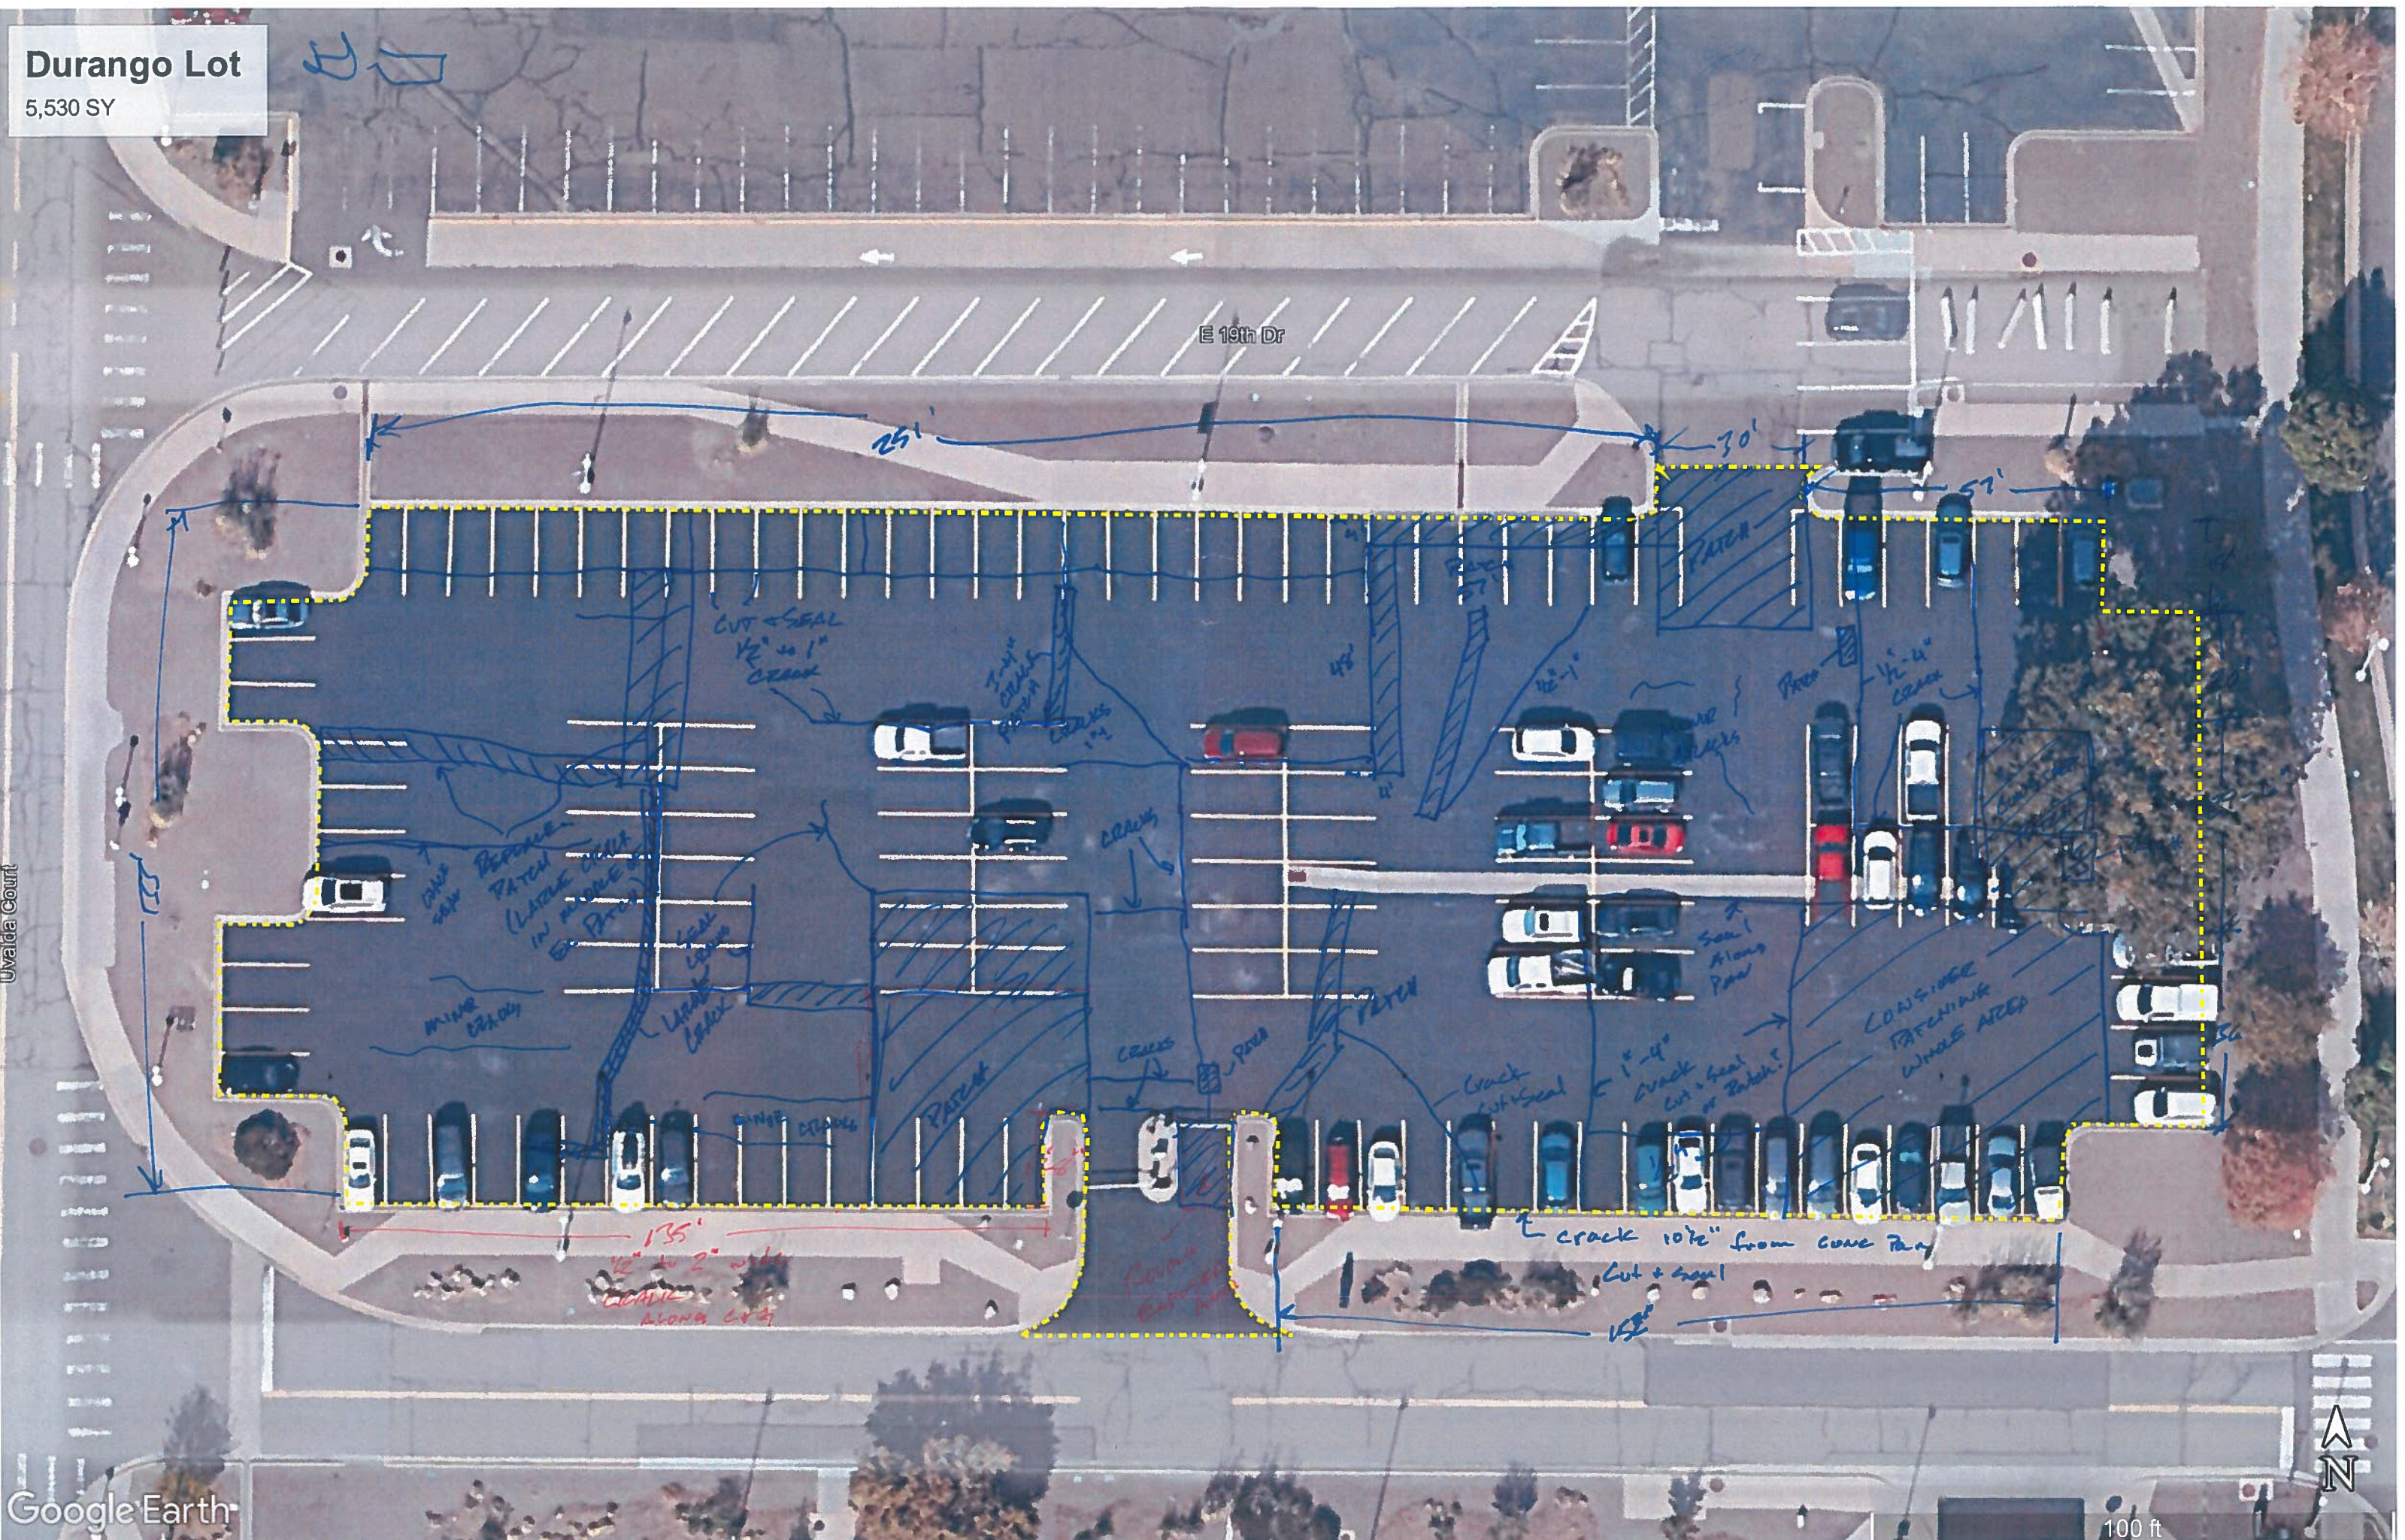
Durango Lot

joint sealant is recommended. Previous areas have been patched in the lot and appear to still be in good condition, with a joint sealant recommended around the patched areas.

- Aspen Lot: Asphalt Full-Depth Repair (Remove/Replace) of the recommended areas and intermediate crack sealing, followed by Asphalt Slurry Seal of the entire lot with new pavement markings.
- Durango Lot: Asphalt Full-Depth Repair (Remove/Replace) of the recommended areas and intermediate crack sealing, followed by Asphalt Slurry Seal of the entire lot with new pavement markings.
- Frisco Lot: Asphalt Full-Depth Repair (Remove/Replace) of the recommended areas and intermediate crack sealing, followed by Asphalt Slurry Seal of the entire lot with new pavement markings.
- Leadville Lot: Asphalt Full-Depth Repair (Remove/Replace) of the recommended areas and intermediate crack sealing, followed by Asphalt Slurry Seal of the entire lot with new pavement markings.
